DRIVESHAFT ALIGNMENT INDICATOR

Frank A. Bill, Robert B. Bossler, Jr.  
KAMAN AEROSPACE CORPORATION  
Old Windsor Road  
Bloomfield, Conn. 06002

January 1979

Final Report for Period November 1975 - May 1978

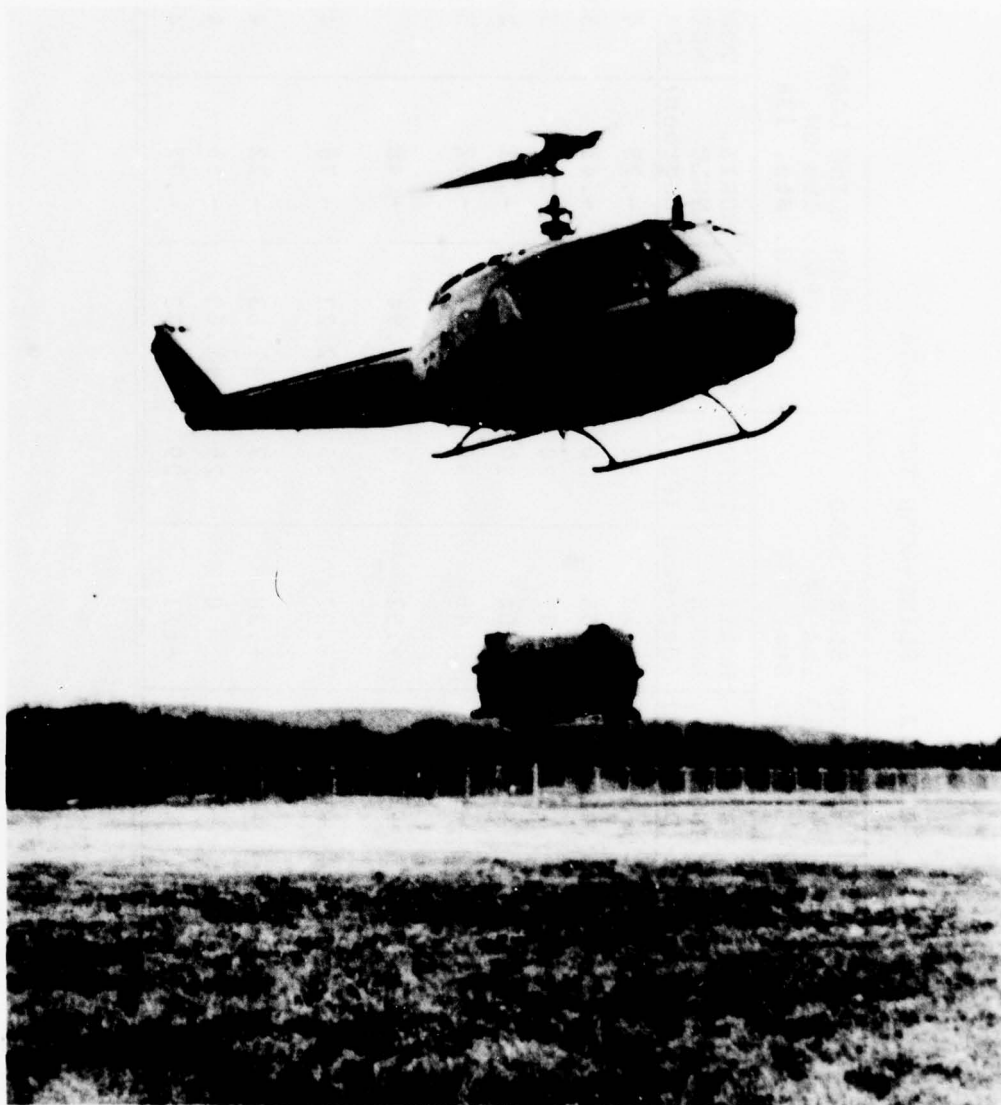
Figure 33. Army UH-1H with a 2000-Pound Sling Load.
